MINE SITE VISIT REPORT New Mexico AML Program

Mine/Project Name: Barbara J # 2 Mine – Northwest of Grants, New Mexico

Purpose of Visit: Maintenance inspection to the Barbara J # 2 mine, part of the legacy site

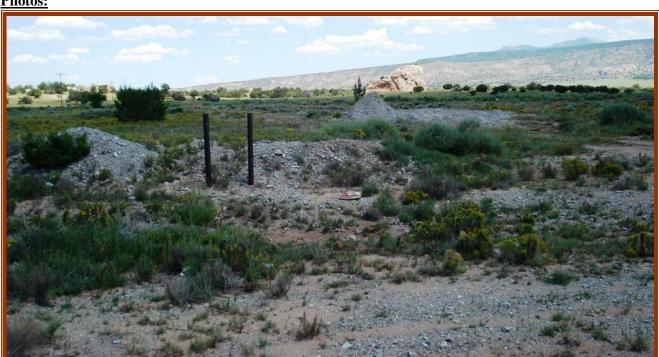
Background radiometric levels of 20 & 21 μ R/hr at 1-meter and ground level respectively, were read utilizing a Ludlum Model-14C survey meter with a NaI Model 44-2 Gamma Scintillator probe and were taken near the Piedra Trieste site. The overall waste and ground within the middle portion of the disturbance area have radiometric levels of 100-157 μ R/hr at 1-meter and 100-214 μ R/hr at ground level.

Mine Waste Looking East

Further action recommended to mitigate radiometric levels. The open vent shaft needs to be backfilled.

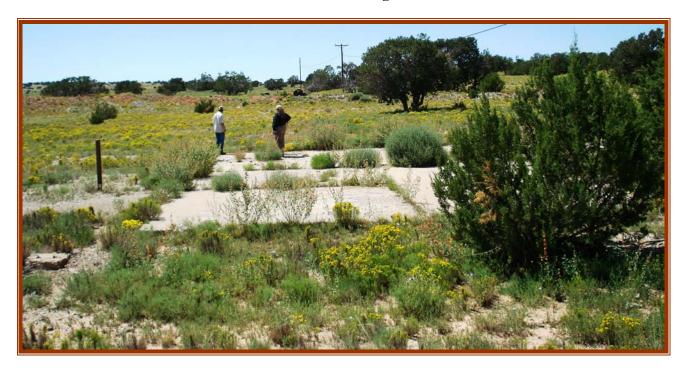
Concrete Pads Looking West

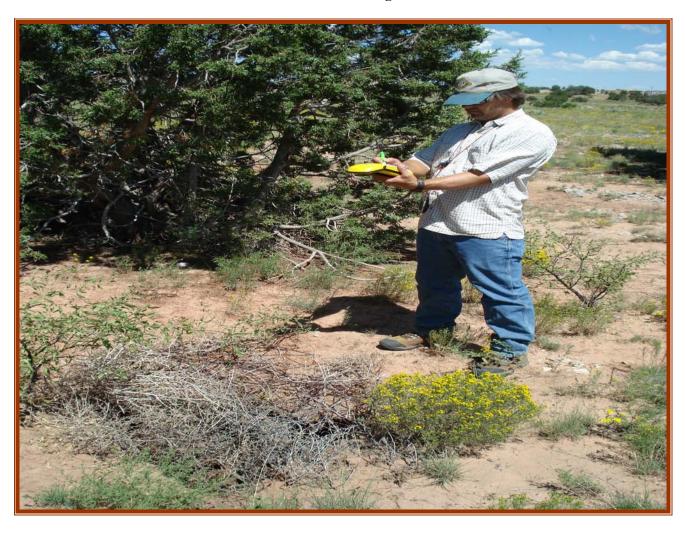
This site has areas of mounded waste and multiple concrete pads as well as some hoist equipment. There was one open vent shaft on this site. For complete details see topographic GPS info using the MapGuide map found at http://164.64.103.6/mmdtest/AML_Uranium-DEV.htm

Open Vent Shaft Looking North
